ACCESS AUDIT

**THREE RIVERS LEARNING TRUST
KING EDWARD VI SCHOOL
COTTINGWOOD LANE
MORPETH
NORTHUMBERLAND
NE61 1DN**

**Project No.
C561c**

Building
Surveyors
Limited
Media
Exchange 1
Coquet
Street
Ouseburn
Newcastle
NE1 2QB

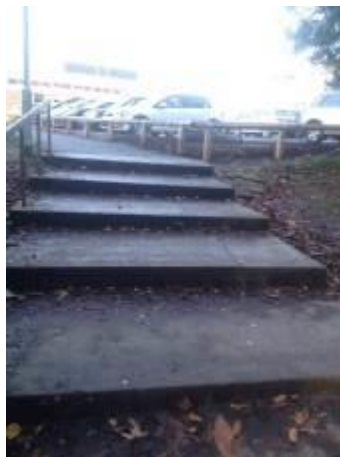
P01 – Access Steps to new car park

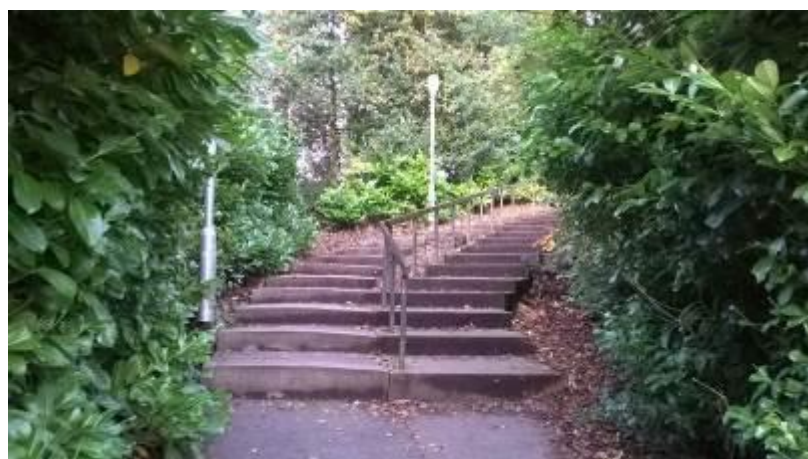
P02 - Typical access steps

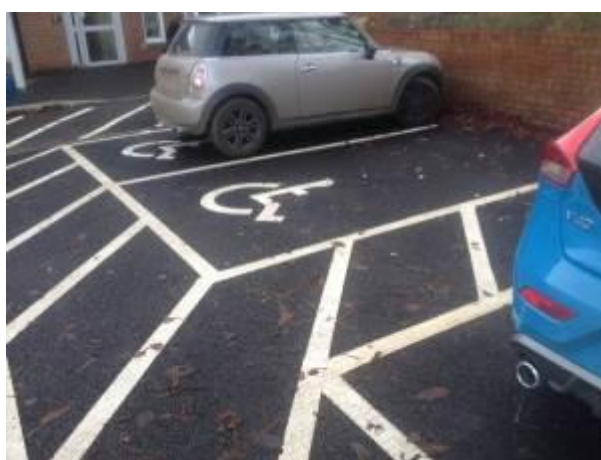
P03 – Dedicated accessible parking bays

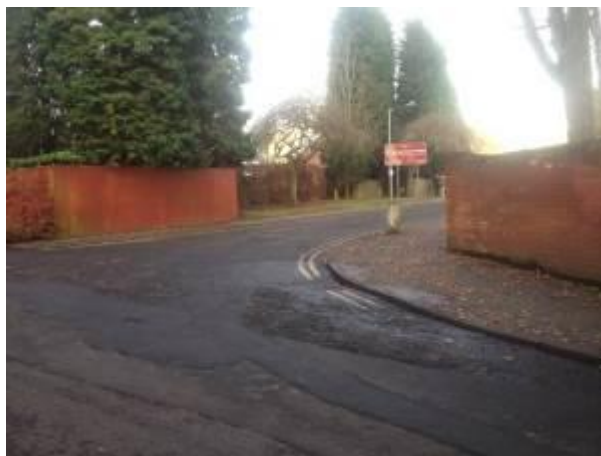
The main entrances are reasonably identifiable from the front façade but would benefit from improved informational and directional signage. The entrance doors had a clear opening width of 1820mm. It would be prudent to provide a door and a half set or upgrade current set with automatic door opening function in this location to improve access for wheelchair users.

P04 – Main Entrance to School

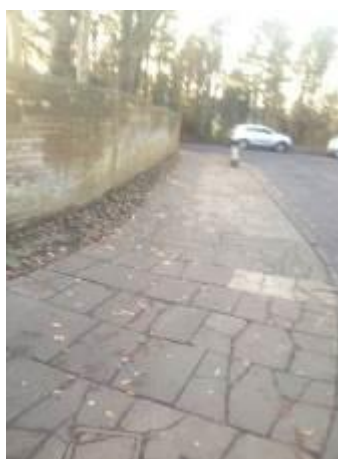
1.04	Approach surface/path/pavement condition	P	Pavement is mixture of concrete and flagstone	All foot paths serving all entrances as well as the main approaches are in fair / poor condition. All footpaths where required to be taken up and re-laid where possible and existing concrete surfaces to be tarmac.	Item	1	£20,000

P05 – Access path in poor condition

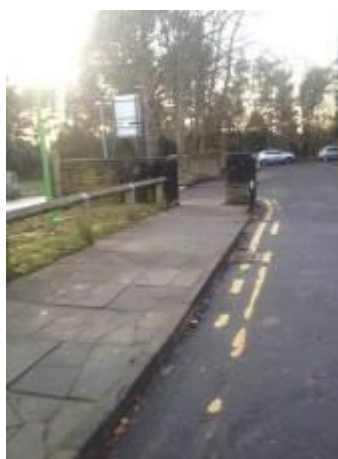
P06 – Access path in poor condition

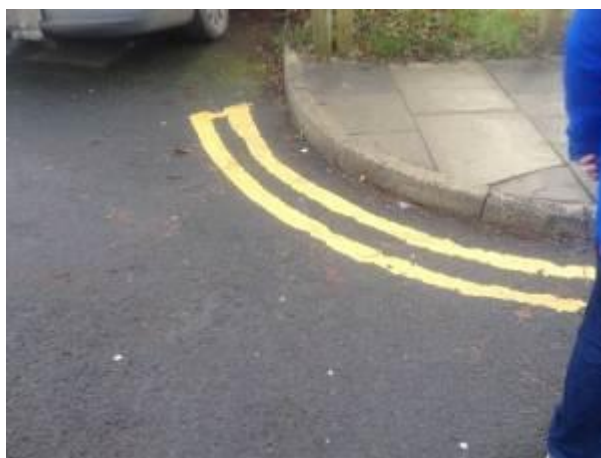
It was noted that there was a lack of drop kerbs and tactile indicators to where the pavement abuts the roads and car parks. Tactile indicators and drop kerbs should be provided throughout the site. All flagged concrete footpaths would benefit from being lifted and re-bedded.

P07 – Drop kerb required.

1.05	Obstructions/hazards/street furniture	N	No hazards noted	–			–
1.06	Dropped kerbs - requirement/specification	N	Yes dropped kerbs are provided	Dropped Kerbs to be provided to numerous points around the site, main entrance, foreign languages, car park etc.	Item	1	£1,000.00

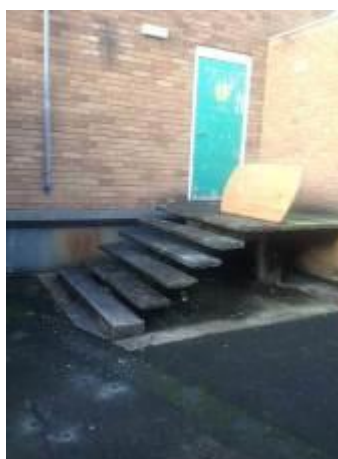
P08 – Fire escape stairs poor

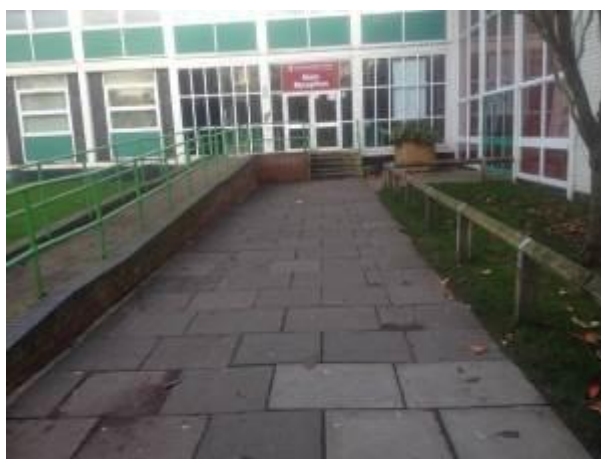
On entering the building, a formal reception counter/hatch is formed for both reception points. How the hatch is not formed to a height that is recommended by the standard set by BS8300: 2001 section 11.1, for the purposes of signing 'in' and 'out'.

P09 – Main Entrance Reception

6.09	Call bell - height/colour differentiation/signage	N	No call bell provided	Install call bell to BS 8300:2009 Section 6.1	item	3	£50.00
6.10	Provision of induction loops/ alternatives	N	Not noted at time of survey but usually provided with portable device.	Provide Induction Loop	Item	2	£100.00

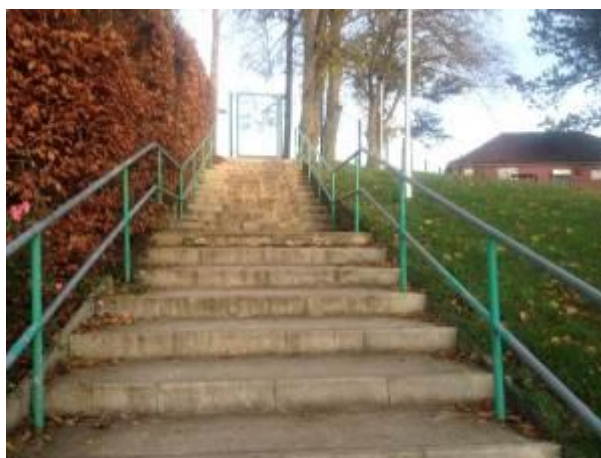
P010 – Access steps to top sports field.

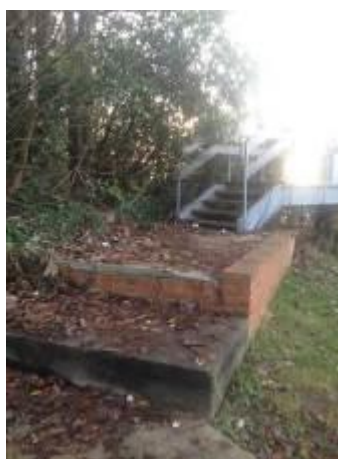
Even though a refurbishment has taken place to the 6th form block no lift access is provided to the first floor area and the fire escape situated to the first floor is in a poor condition and requires replacement/overhaul.

P011 – Fire escape in poor condition (6th Form Block)

14.01	Fire Escape Staircases	Y	Fire Escape stair/lading to first floor fire exit to 6 th form block in poor condition	Allow to overhaul or replace in the short term	1	1	£5.000.00

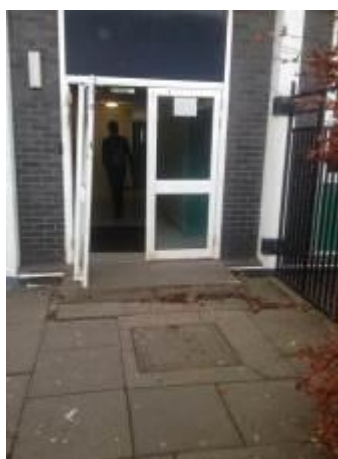
The perimeter exit doors are suitable in width; however some doors were noted to be in poor condition and only some provide level access to allow for independent wheelchair access. It was noted that most external doors are hindered by steps, or poorly installed ramped sections all of which do not comply. It is recommended that an adequate landing should be provided

P012 – External Door in poor condition

5.06	Provision (need for) automatic doors	N	No provision provided	Allow to upgrade main entrance doors to be automatic and provide push button function externally and internally. Consideration should be given to replace external doors. As per summary some external doors are in poor condition		1	£1500.00

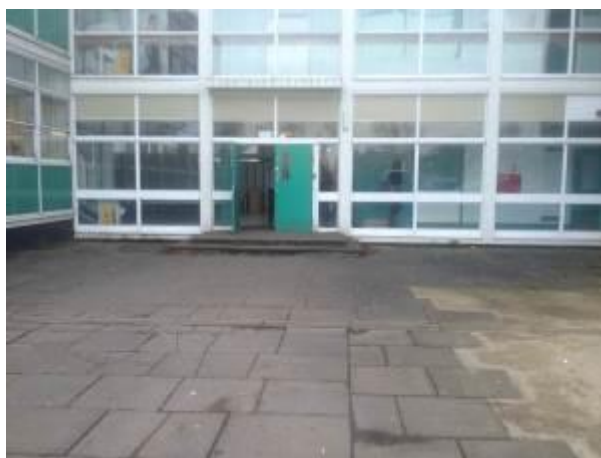
P013 – Entrance steps into rear pupils entrance.

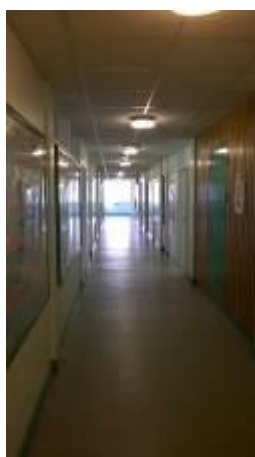
The tonal contrast and lighting levels are considered to be un-sufficient throughout the building. Decoration to be carried out.

P013 – Typical Corridor_Poor contrast

7.05	Floor/wall/ceiling colour contrasting	P	Poor colour contrast throughout building.	Allow to redecorate all (circulation areas)		2	£20,000
			Sections of floor are in poor condition. Areas lifting causing tripping hazards	Allow to replace during next cyclical period corridor & lobby area floor finishes. Psum allowed for repairing/replacement in the short term		2	£2,000

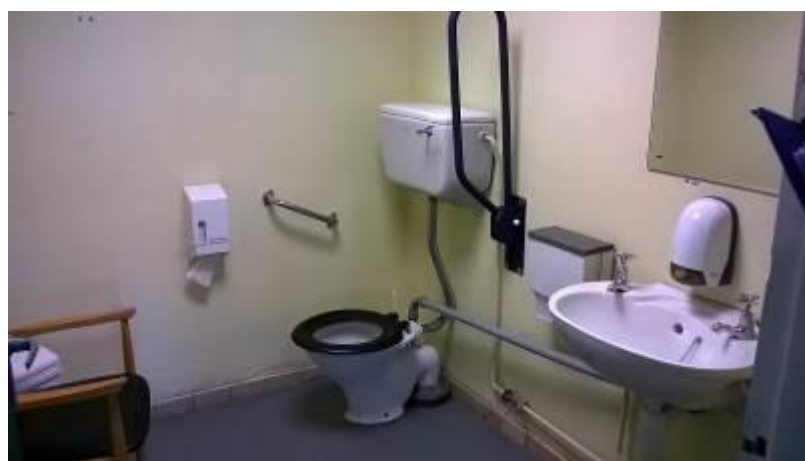
Accessible toilets are located to ground and first floor. The ground floor toilet is of poor quality and does not comply with modern day building regulations and should be replaced in the short term along with a full refurbishment of the room. The accessible toilet located to the first floor is a wet room with modern sanitary ware installed which are compliant. Please note staining was noted to the ceiling; further investigations required to determine remedial works to resolve water ingress issues.

P014 – Accessible toilet not compliant.

Accessible toilet to the ground floor should be upgraded to comply with Part M of the building regulations as below;

Item Ref	Item	Provision Made? Y, N or Partial	Comments/Site Notes	Recommendations	Qty	Priority (1,2,3)	Cost
11.0 1	Provision/location	–	Accessible toilet provided to ground and first floor only. Accessible toilet located to the music and 6 th form block in good condition and both meet current guidelines.	Accessible toilet (main block) situated to the ground floor in poor condition and does not comply. Allow to fully refurbish toilets including below items if required.	1	1	£3,500
